12. Winterborne Monkton – Discovering the Ridgeway

Key Features

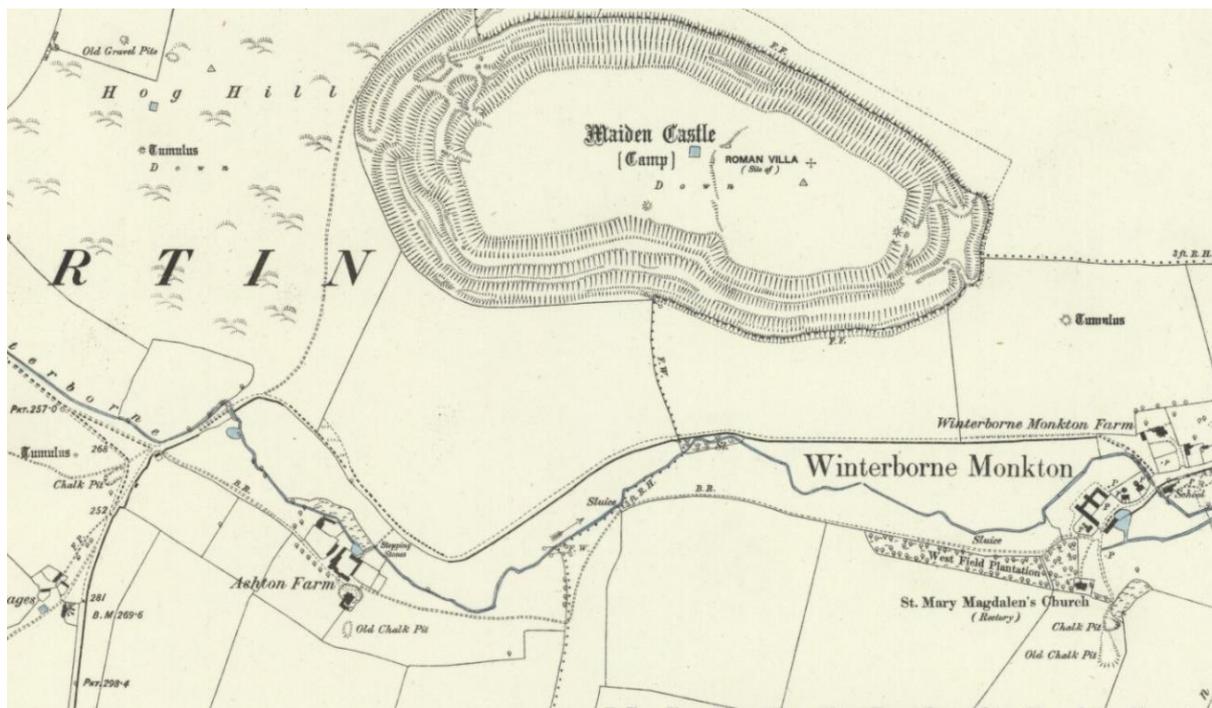
Extract from 1888 Map prior to this the settlement was concentrated on the south side of the water course.

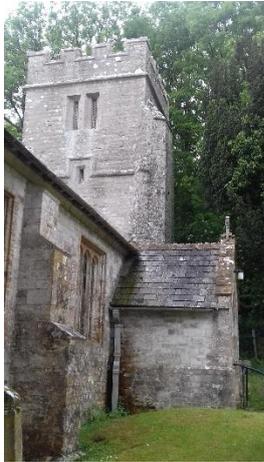
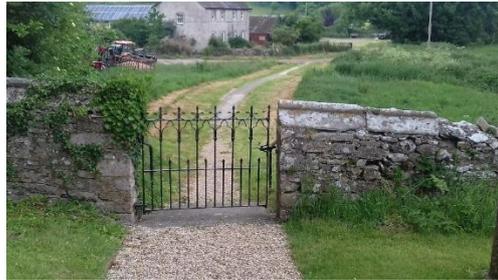
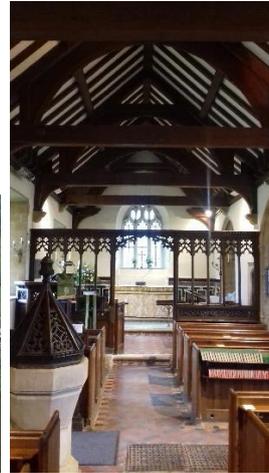
The Parish Church of St Simon and St Jude.

There is one listed building in the village – the Grade II* Parish Church of St Simon and St Jude's Church, at the south west end of the settlement. The walls are of local rubble and the roof covered with lead and slate. The body of the church is a simple rectangular structure of C13 origins. The chancel is structurally undivided from the nave. The north porch was added in the C15 and subsequently rebuilt. The west tower was added c.1500. A restoration began in 1870 and included the rebuilding of the north wall of the chancel and nave east of the porch. The minstrels' gallery under the tower was removed at this time and new Chapel built in 1875 in memory of Miss Ellerie Bessie Williams of Herrington. Her effigy divides the Chancel from the Chapel.

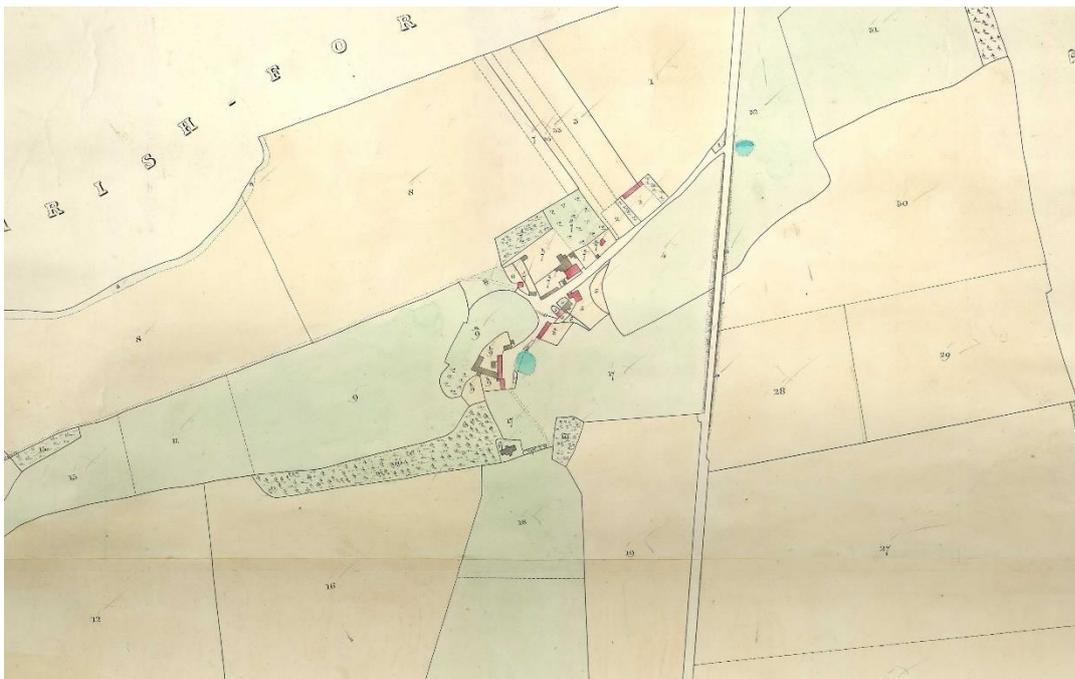
The Tithe Map (undated but between 1837-1841) illustrates a collection of farm buildings accessed from the Dorchester to Weymouth road, with a church, parsonage (demolished and relocated), farmhouse and cottages all still in use. The village school, built in 1906 and closed post-WWII has become the Elworthy Church and Village Hall.

The Tithe Apportionment states:

1. Rev'd Joseph Foster owner, William Lock occupier allotment - arable,
2. George White owner, Robert Phelps occupier, dwelling houses, garden & plantation,
3. Rev'd George Wood owner, Robert Phelps occupier, allotment on north field,
4. Rev'd Joseph Foster owner, William Lock, Harris Meadow,
5. Rev'd Joseph Foster owner, Rev'd John Charles Binstead, parsonage House, Garden and premises,

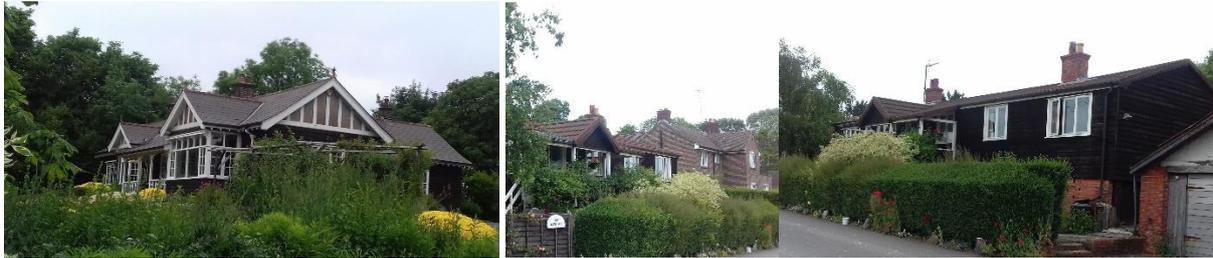
Southmead and other bungalows on the north side of Herrington Lane.

There is a ribbon development comprising bungalows dating from the 1920's on the north side of the road on the eastern approach and Southmead is the most intact example of this period of building.

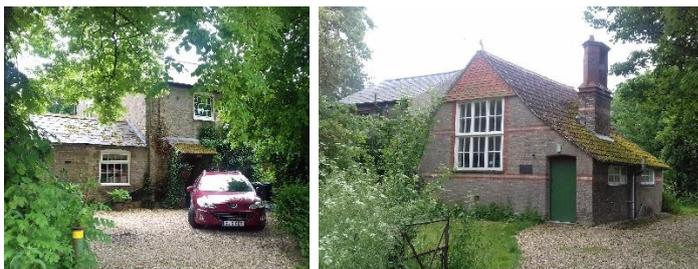
The School House and The Arts & Crafts inspired Ellworthy Church Village Hall with bellcote and chimney.

The buildings of Winterbourne Monkton are almost all of Purbeck stone with flint and some cob. Upper Purbeck Beds were quarried at Upwey and Flint, found as nodules in the chalk downlands. Boundary walls are of flint. Typically detached and semi-detached cottages have coursed Purbeck stone walls with ashlar or gault brick window and door heads and a variety of sashes, 8 over 8, later casements. Some cottages have been with porches and rear additions with good ironwork gates in the flint and stone walls. All buildings share the same central chimney stack detail and slate roof covering with the exception of the former school which has a tile hung gable end over bricks with an offset chimney.

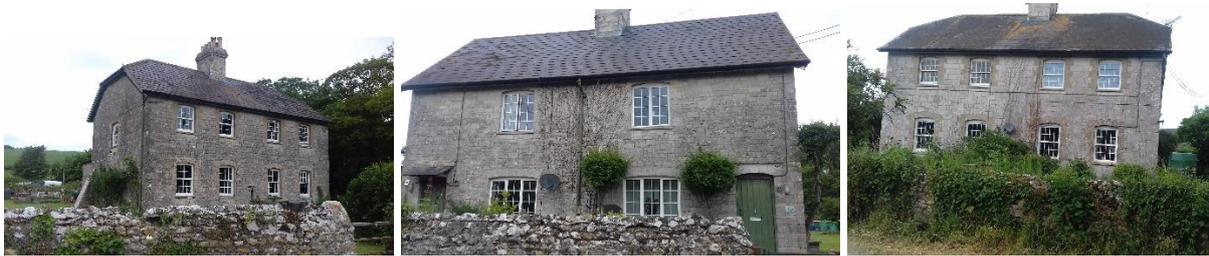
Manor Cottages leading to the Farmhouse right and yard below.

The farmstead at Winterborne Monkton is so symmetrical and intact that it would suggest a well tried and adaptable courtyard arrangement. New designs sought to provide more accommodation in larger yards divided by shelter sheds in the E shaped plan which is what survives at Winterborne Monkton Farm today.
